## Publication No. 84-e32

#### DEPARTMENT OF ECOLOGY

MEMORANDUM September 4, 1984

Subject: Eagle Harbor Facilities Tours and Historical Review

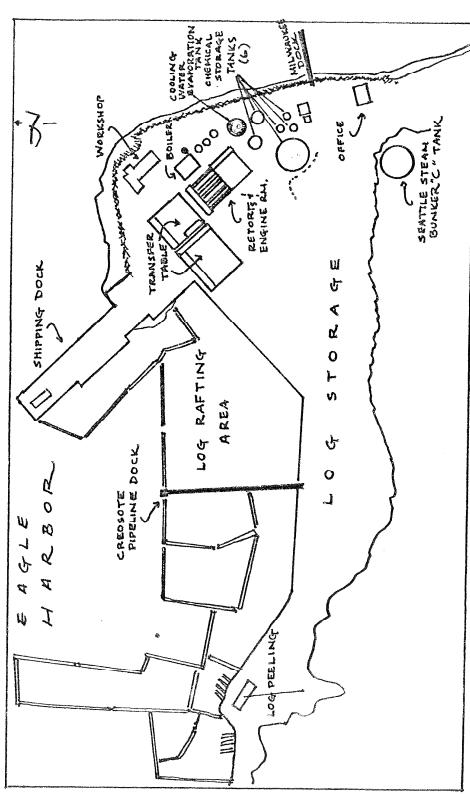
2: The wyckoff Co. site plan, Eagle Harbor, WA. Figure

The Wyckoff Company Eagle Harbor facility occupies approximately forty acres on Bill Point (Figure 2). Site elevation is approximately ten feet above sea level. Most of the facility is located on pervious, fill materials; however, paved roads and surfaces are present in the log storage area. The facility has approximately 0.8 mile of shoreline that has been reinforced and improved over the years. In addition, the Wyckoff Company owns the tidelines to extreme low tide (approximately -4.5 feet), and has a twelve-year lease on bedlands in its log boom storage and docking areas (DNR, 1984).

Creosote is unloaded from barges every twelve to fifteen months and transferred by pipleine from the westernmost dock to the storage tanks (Figure 2). However, no shipments of creosote had been received for six years. Aromatic oil is transferred from the eastern (Milwaukee) dock via pipeline to storage tanks. The oil is mixed with solid pentachlorophenate salt which arrives by truck.

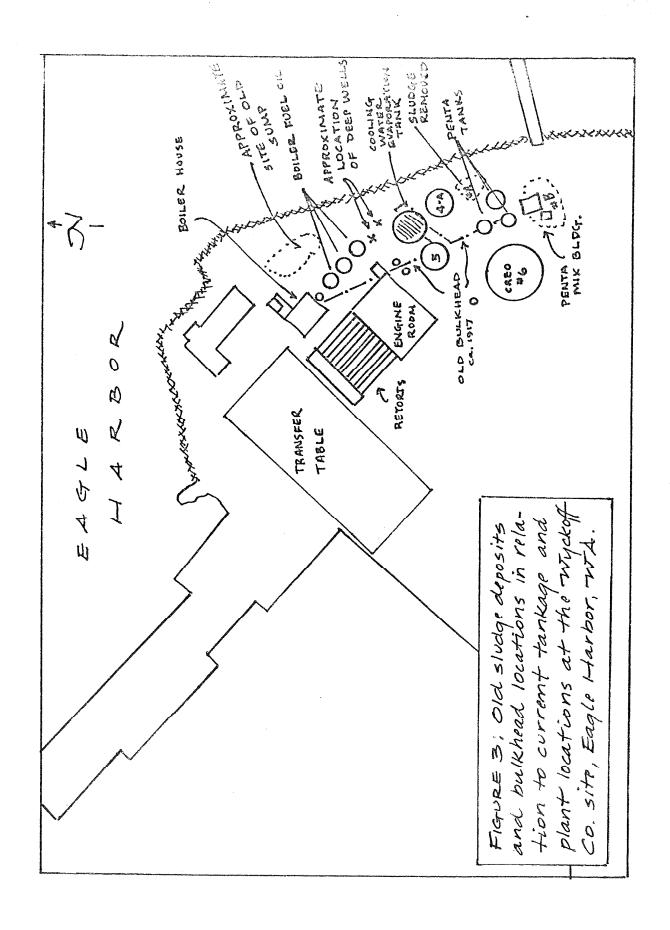
Figure 3 shows the northeast portion of the facility in more detail. The structures located here that are directly associated with wood-preserving operations include:

The wood-preserving effluent system is relatively new. The old system discharged into a sump (Figure 3). Transfer from the old system to the new, closed system was accomplished in late 1981 or early 1982.

Immediately after being treated in retorts, logs are moved through the transfer table to on-site storage areas (Figure 3). Freshly treated logs contain residuals of preservative in wood cracks. This preservative drips to the ground. As previously mentioned, heavy contamination of subsoils in the transfer table/treated log storage areas has been detected at other wood-preserving operations (Thompson, Wardrop, et al., 1978; Stoddard, 1984; S.W. Regional Staff, 1984).

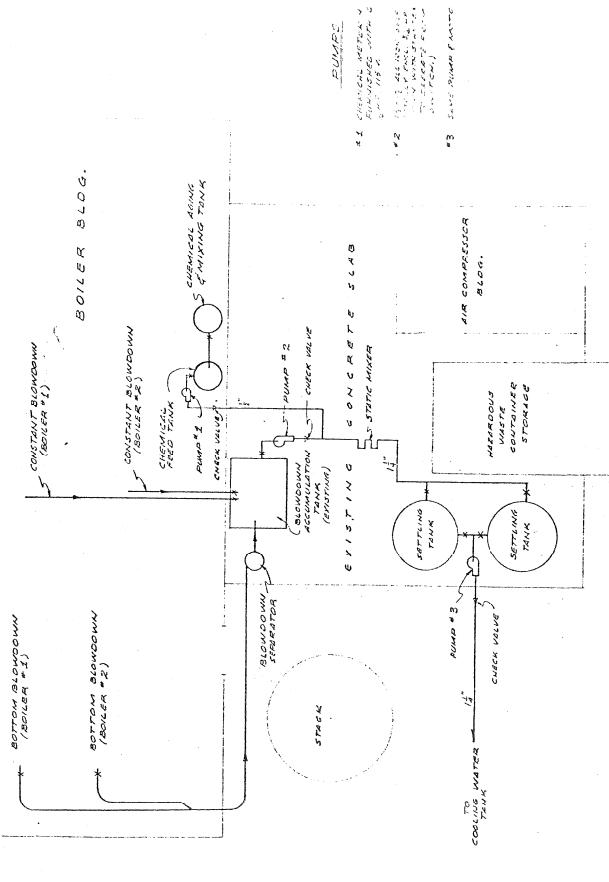
Figure 5: Schematic diagram of the boilor blowdown treatment system at the trigology Drawn by D. Johnson, Wyckoff Co, 481.

Blowdown is created in the two boilers at the plant, and this effluent is drawn-off and treated in the blowdown disposal system (Figure 5).

Blowdown contains boiler treatment chemicals and concentrated minerals and salts from the make-up water.

- 1. The solids in the bottom blowdown are initially separated from the water using a settling tank.
- 2. Water from this initial separation is added to the constant blowdown water.
- 3. Flocculants and pH-adjusting chemicals are added and mixed with the combined dowdown water.
- 4. Floc and solids are settled-out in two additional tanks.
- 5. The water phase is drawn off the top of the settling tanks and piped to cooling water evaporation tank.

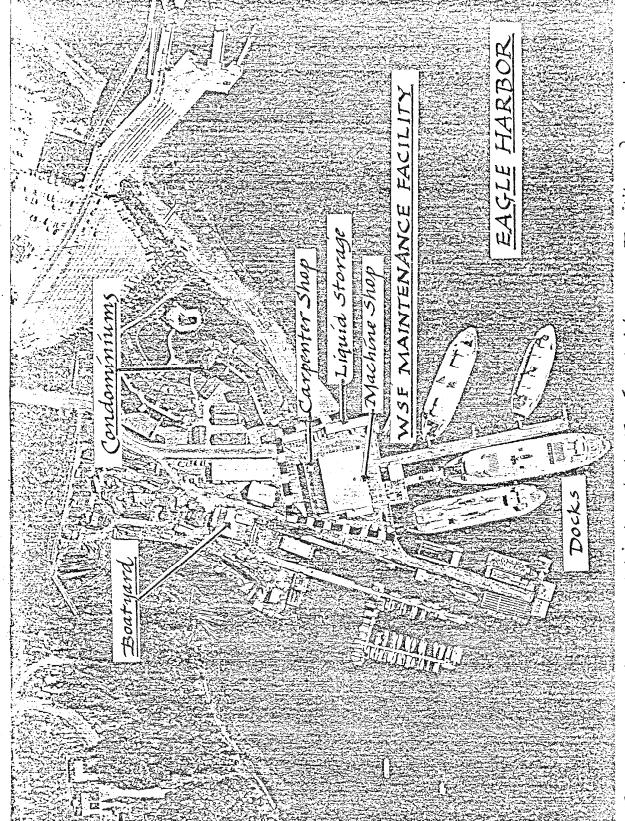
properties, Eagle Harbor, NTA. March 1984 USEPA, Figure 8: Site plan of washington State

The WSF Maintenance Facility is located on approximately three acres on the north shore of Eagle Harbor (Figure 1). The facility is used for routine repair and maintenance of the state's ferry fleet. The facility includes (Figure 8):

Repainting involves removal of cracked and peeled coats of paint and application of new paint. Removal is all performed by scraping and chipping; no sand-blasting equipment is used. Paint sprayers are used to apply fresh coats of paint. All paint work is performed at the docking berths (Figure 8).
